Manhole Inspection Summary

Manhole # S27S1_013MH

Insp Date: **5/5/08 1:36 PM**

Location Address: **800 W. Patapsco Ave.**

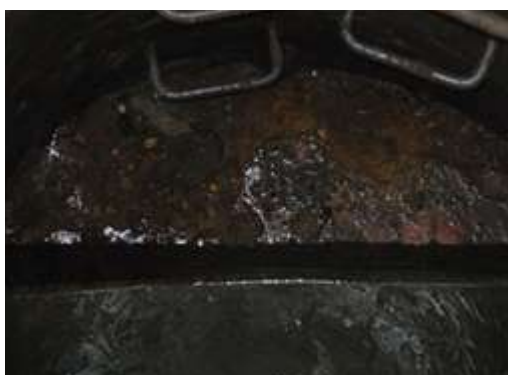
Defect 1

Debris on bench

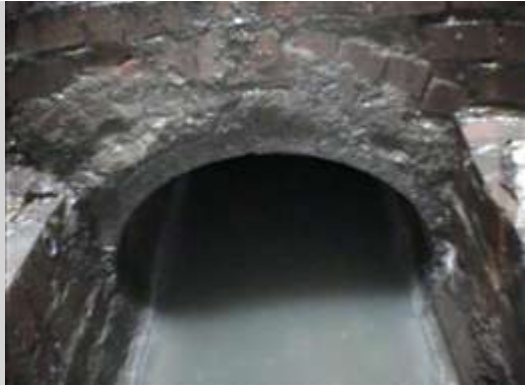
12 O'Clock Outflow

21 in. Circular Gravity Sewer
Pipe Out @ 12 O'Clock

Pipe Height: **22.8** (in.) Rod and Bar (Angled)
Pipe Material: **Concrete** ☐ Pipe Lined
Invert Depth: **15.04** (ft.) Flow Characteristics: **Slow**
Deposits: ☒ None ☐ Mud ☐ Sludge ☐ Debris ☐ Grease
Silt Depth: (in.) Deposits Extent:
Infiltration: **None** Pipe Seal Cond: **Sound**

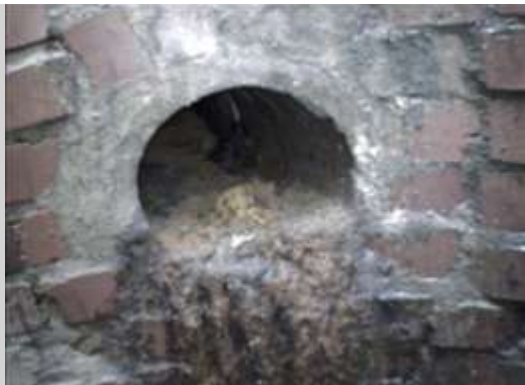
4 O'Clock Inflow

6 in. Circular Service Sewer
Pipe In @ 4 O'Clock

Pipe Height: **8.4** (in.) Rod and Bar (Angled)
Pipe Material: **Unknown** ☐ Pipe Lined
Invert Depth: **9.58** (ft.) Flow Characteristics: **None**
Deposits: ☐ None ☐ Mud ☒ **Sludge** ☐ Debris ☐ Grease
Silt Depth: **3** (in.) Deposits Extent: **Medium**
Infiltration: **None** Pipe Seal Cond: **Sound**

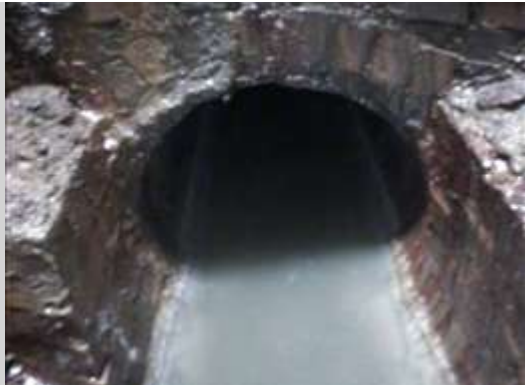
6 O'Clock Inflow

21 in. Circular Gravity Sewer

Pipe In @ 6 O'Clock

Pipe Height: **21.6** (in.) Rod and Bar (Angled)

Invert Depth: **14.74** (ft.) Flow Characteristics: **Slow**

Infiltration: **None** Pipe Seal Cond: **Sound**
